**CASE STUDY:  
TECHNICAL CHALLENGES AND AN INNOVATIVE RESPONSE TO  
LINING OVER EXISTING WASTEFILL (PIGGY-BACK)**

**SUMMARY:** Liner design on to an existing wastefill area.

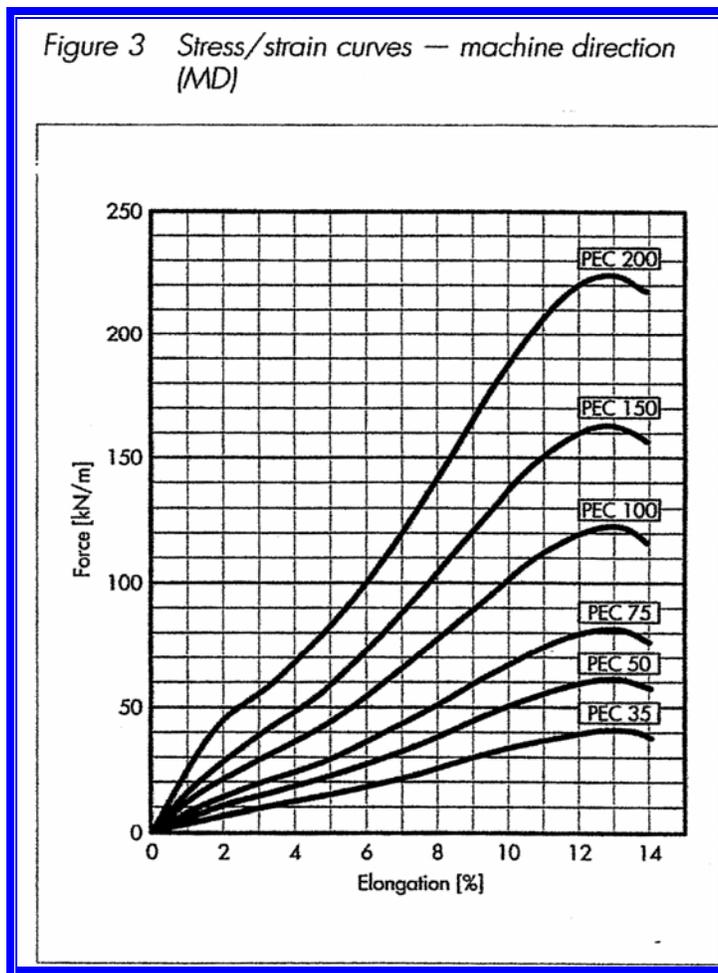
Figure 1 : Graph indicating the typical characteristics of the geosynthetic reinforcing grid

This is a product manufactured by Kaytech. It is a biaxial composite geosynthetic reinforcing grid, comprising high tenacity polyester yarn attached to a non-woven geotextile. The grid provides for high tensile strength at low strain, whilst the geotextile interacts with the sand-sized particles to mobilize the tensile strength of the grid. BKS decided to install a 100kN/m grid at 10% strain to reduce the effects of differential settlement. Apart from an anchor trench at the top of the embankment, the grid was placed simply (embedded) in the sandy subgrade layer.

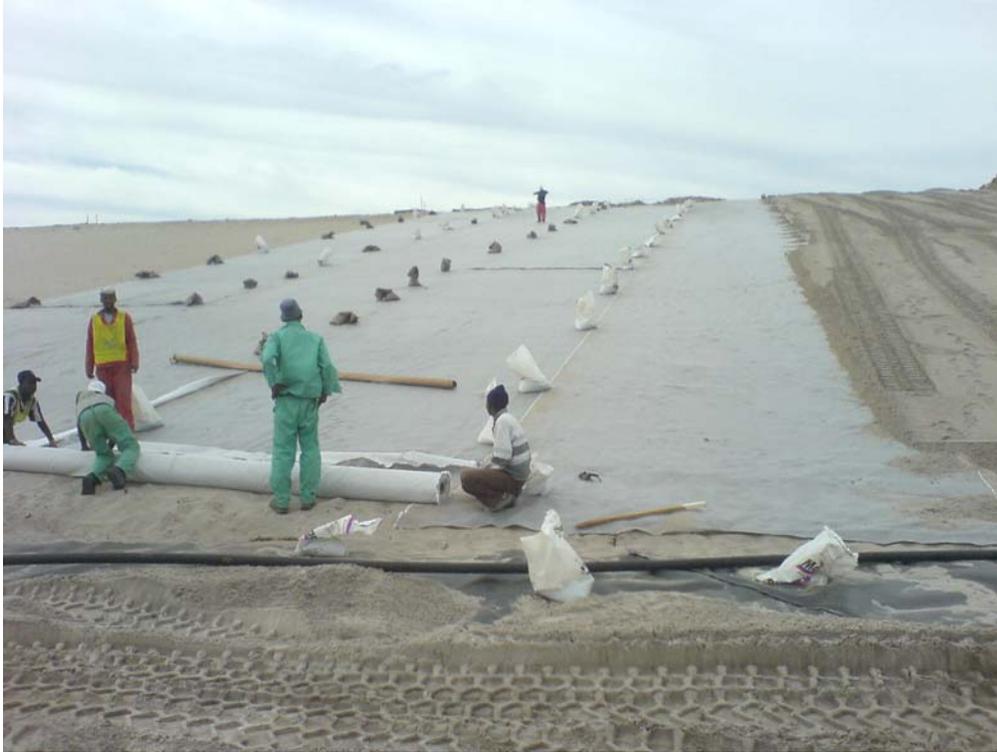
**Photo 1 : Installing the grid.**

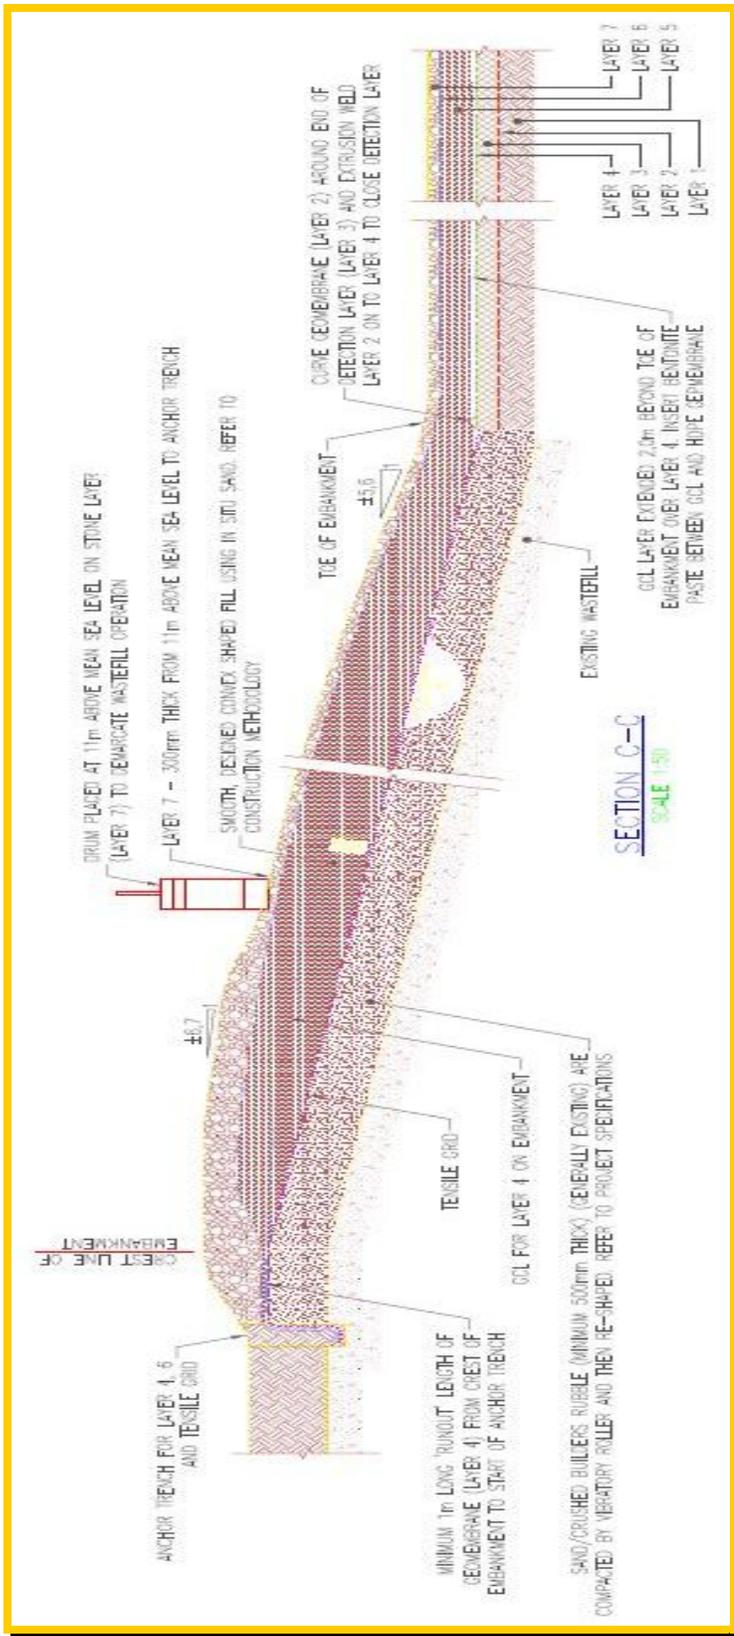
Figure 2 : Section of convex-shaped embankment (image has been stretched)

Shaping of the embankment to a convex shape was done to take up general settlement whilst a geosynthetic reinforcing grid has been added to the subgrade to lessen any potential localised and general differential settlement. As settlement occurs, the geosynthetic reinforcing grid would start to strain and absorb the tensile stresses reducing settlement. At the same time the convex shape of the fill slowly lost its shape whilst all this time the GCL remained under no real tensile stress.

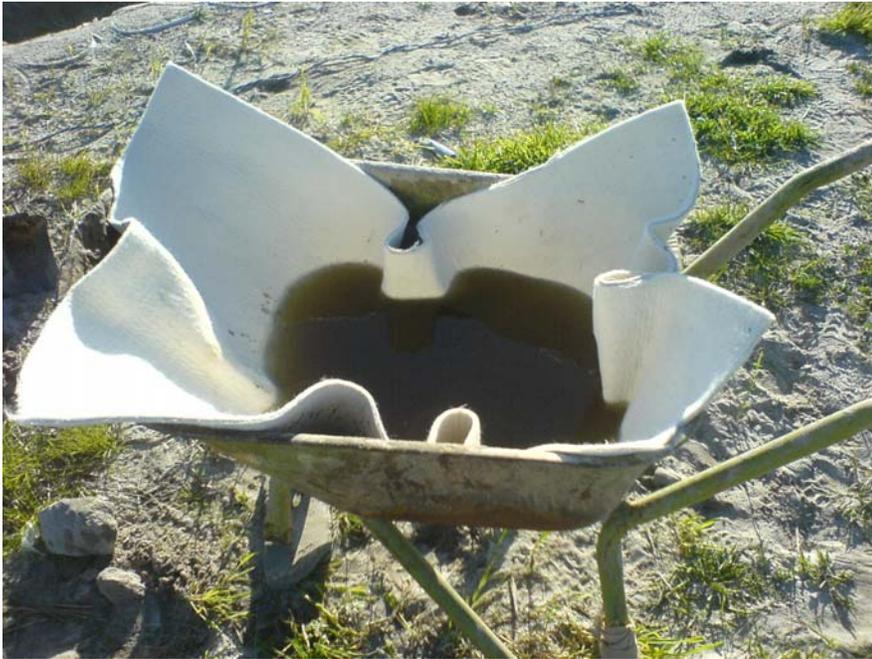
**Photo 2 : Wheelbarrow with holes in the base,  
lined with GCL and filled with raw leachate**

Crude on site testing was done over a few days to visually inspect the hydration of the GCL using raw leachate. Basically the wheelbarrow has holes in the base. The GCL was the only barrier stopping the leachate from leaking out the wheelbarrow. Raw leachate was extracted directly from the landfill cell and poured into the wheelbarrow and left. The area beneath the wheelbarrow was prepared in such a way that any drops from the wheelbarrow would be detected. The test was run over 3 days.

The results were that little or no leachate managed to permeate through.

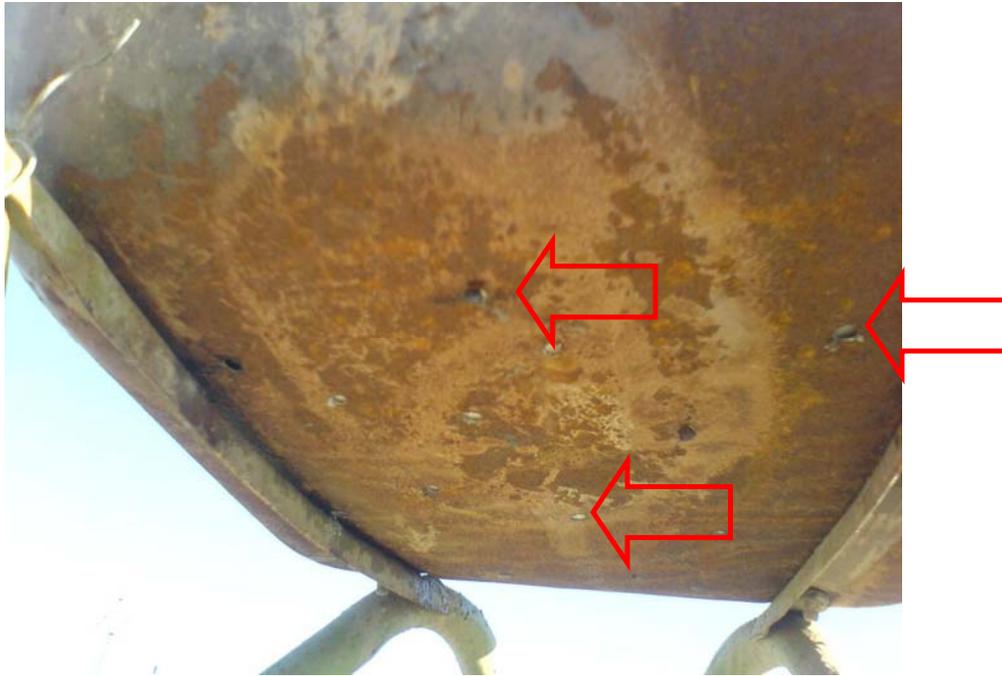
**Photo 3 : holes in the base of the wheelbarrow  
(the arrows show 3 of the many holes.)**

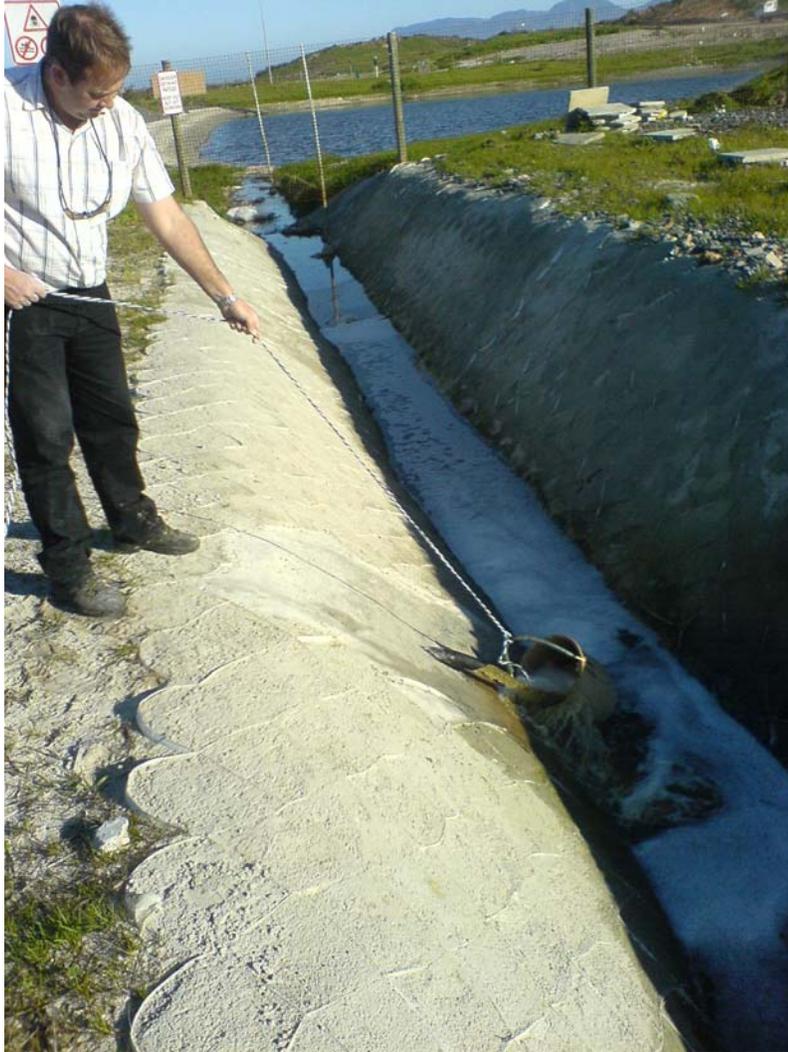
**Photo 4 : Sampling the raw leachate for the crude "wheelbarrow test" and for sending to laboratory in Durban.**

A sample of the GCL was sent to the testing laboratory in Durban together with a sample of the raw leachate for hydration and permeability testing. 20 litres of the raw leachate was put into new fuel cans and couriered to the laboratory in Durban.
