DEVELOPMENT OF THE NYAMASOGA HAZARDOUS WASTE LANDFILL, UGANDA

S. C. A. Louw. Jones & Wagener (Pty) Ltd, Johannesburg, South Africa. silke@jaws.co.za
J. R. Shamrock. Jones & Wagener (Pty) Ltd, Johannesburg, South Africa. shamrock@jaws.co.za

ABSTRACT

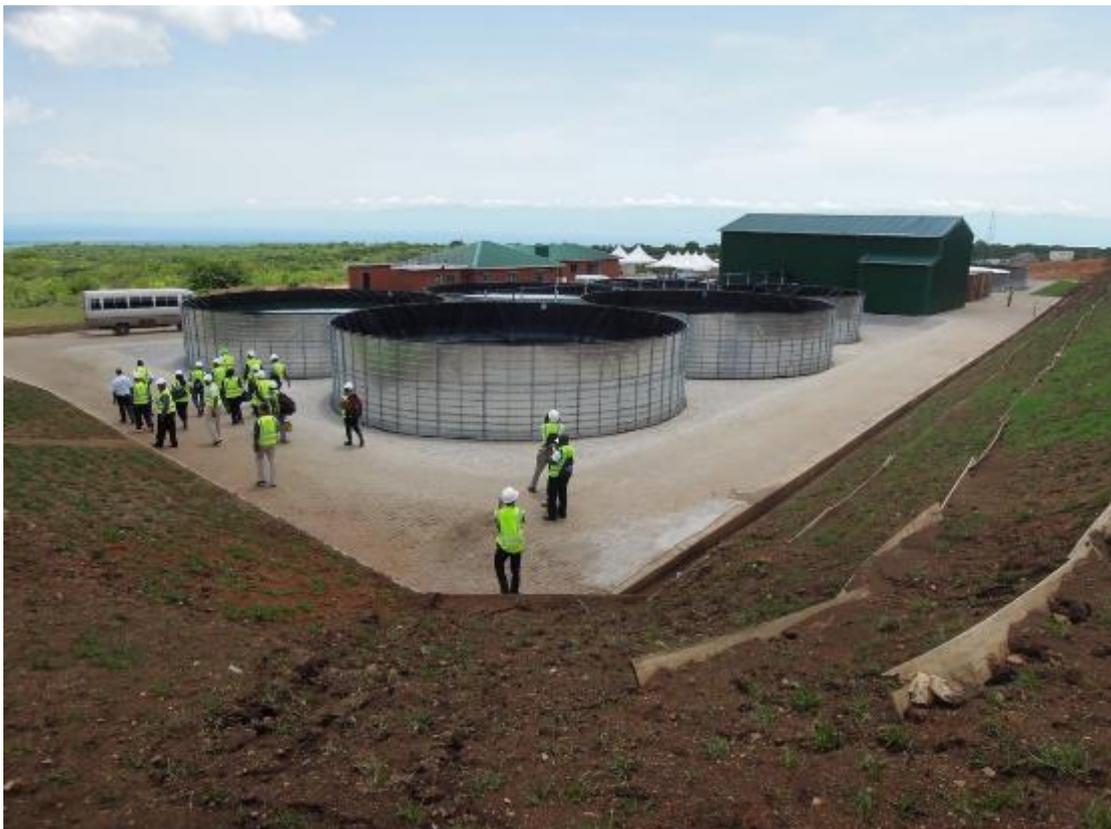
Figure 2. Bunded tank area on the site office platform.

these sumps is then pumped up into storage tanks where they are treated in the Leachate Treatment Plant (LTP) as illustrated in Figure 2.

The LTP has been designed to treat both the contaminated runoff from the landfill and the leachate generated in the cells. The process consists of the following steps:

- pH correction;
- Pre filter;
- Ultra filtration (UF);
- Reverse osmosis (RO).

The permeate from the RO process is stabilised along with the other incoming wastes and disposed of in the landfill.

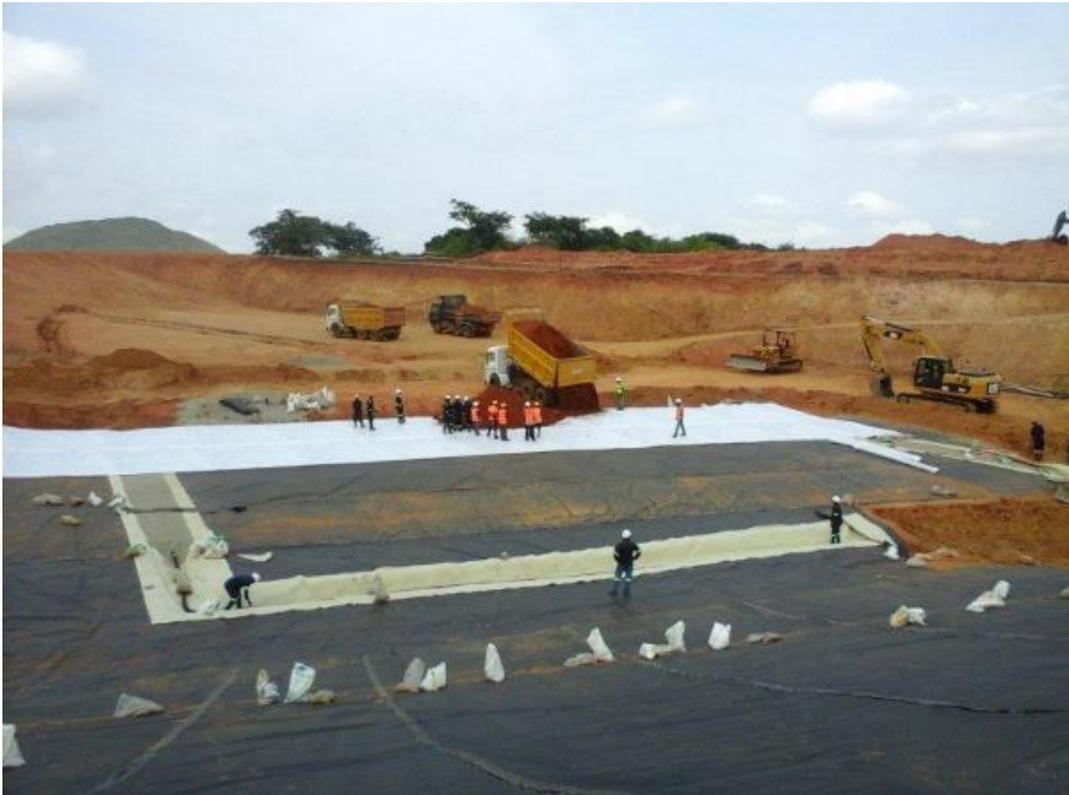
Figure 5. Construction of the secondary composite leachate detection system and placement of first soil layer of the primary composite.

Figure 5 to Figure 7 are some photos during construction of the key elements of the landfill while Figure 8 shows the installation of the ballast layer of the contaminated stormwater dam.

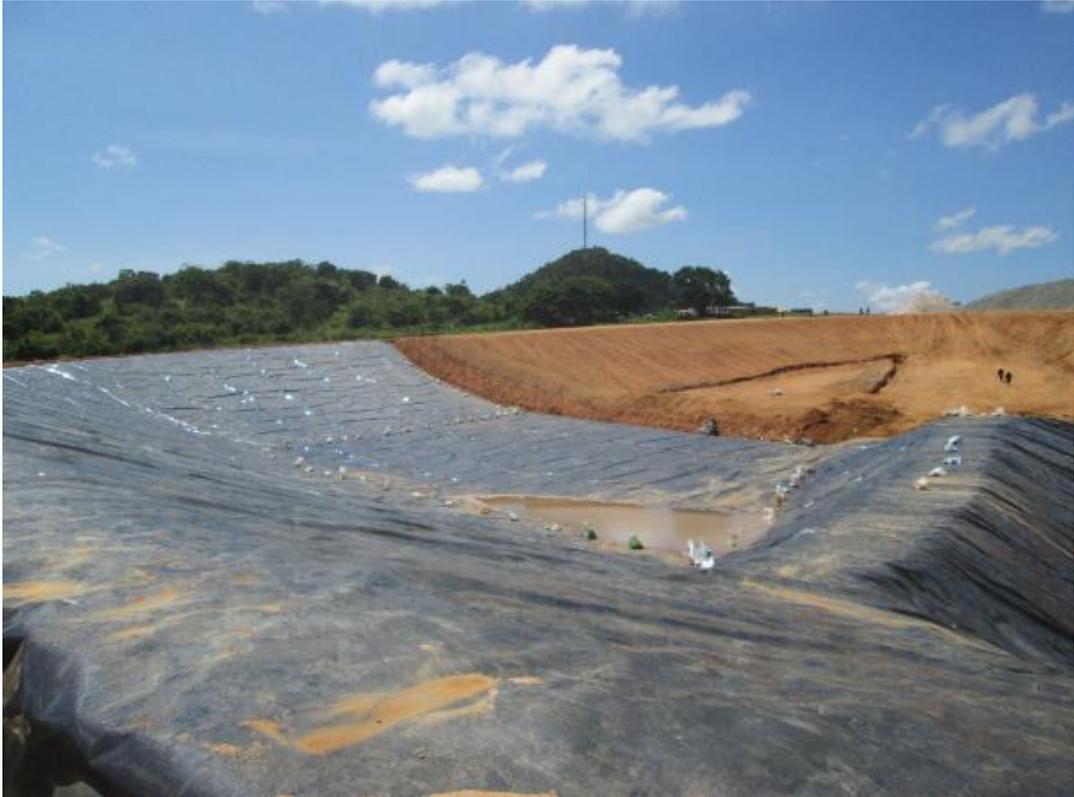
Figure 6. Primary layer of Cell1Ai complete – top of 2 mm monotextured HDPE.

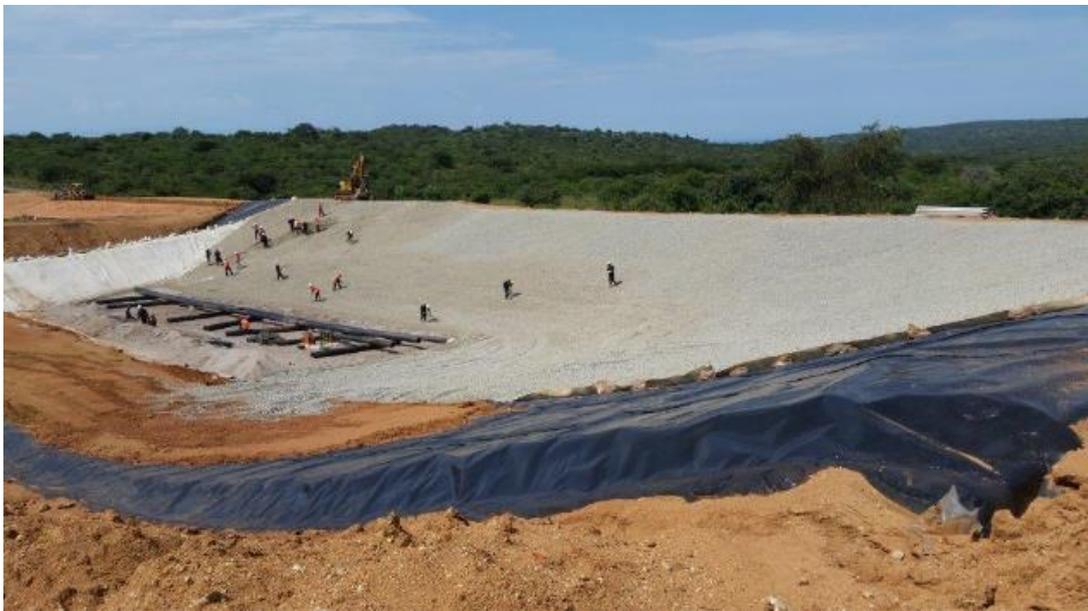
Figure 7. Installation of drainage (leachate collection) layer.

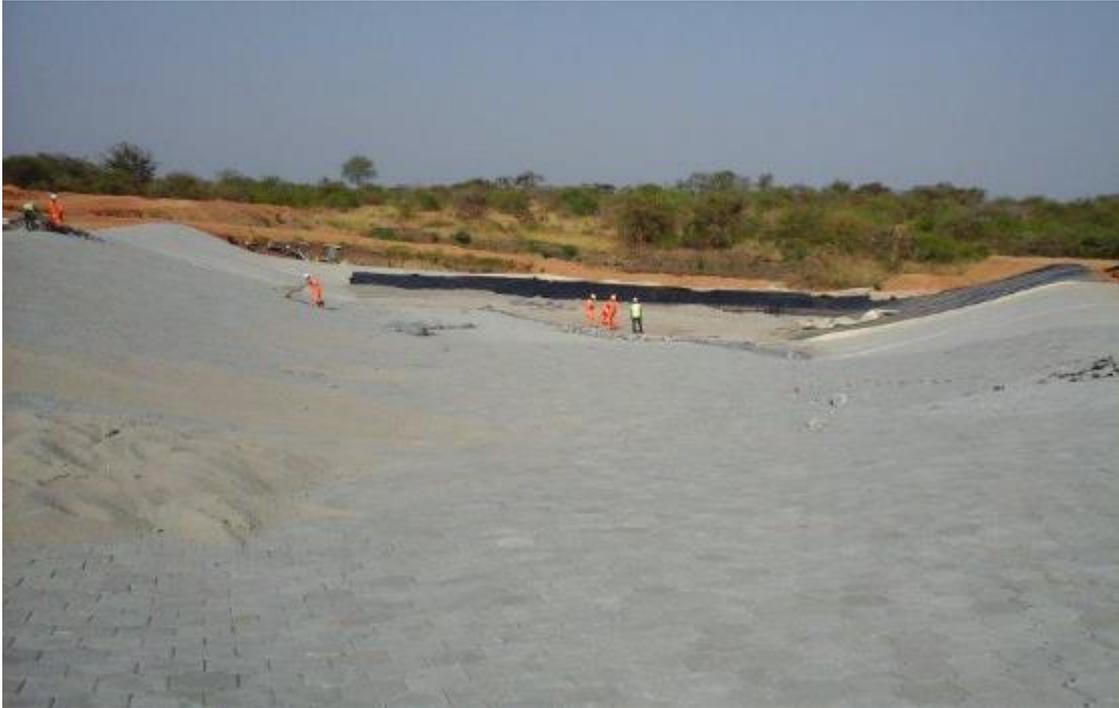
Figure 8. Contaminated stormwater dam.

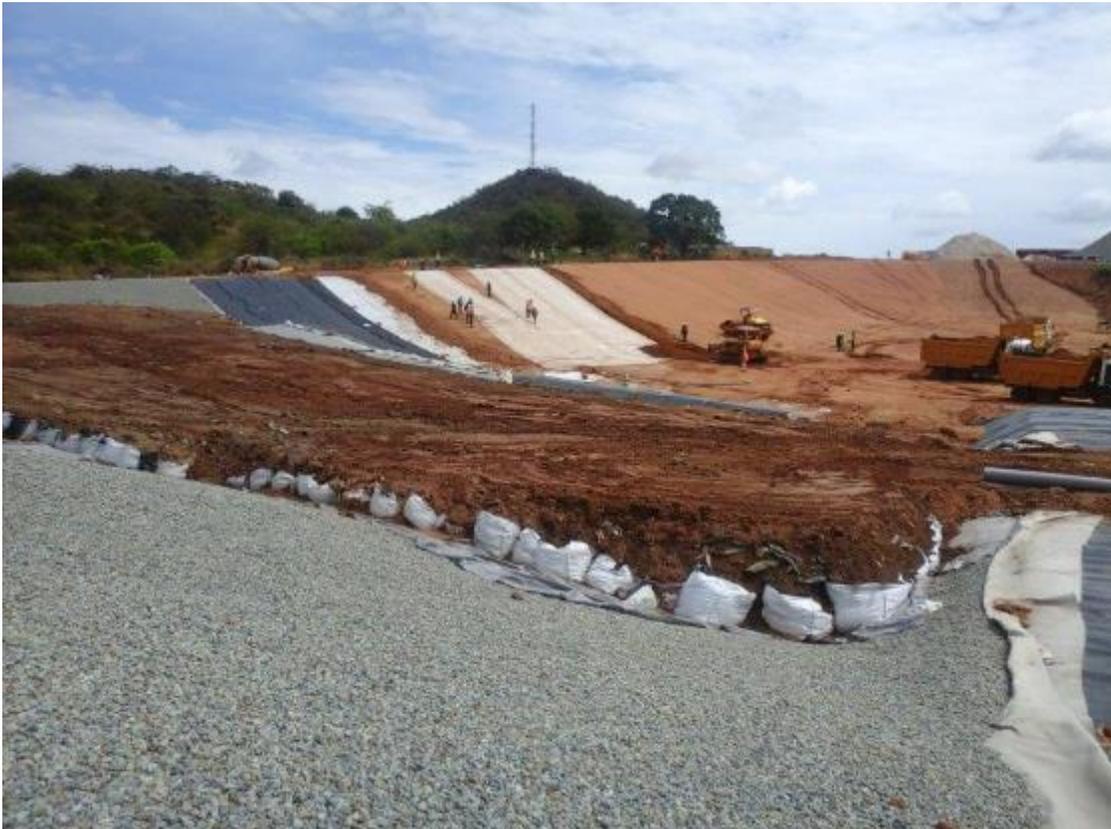
Figure 11. Filling with stabilised waste in Cell 1Ai.

The construction of Cell1Ai and Cell 1Aii is complete as well as the contaminated stormwater dam Phase 1. The treatment plant has been commissioned and the majority of Cell 1Ai has been filled with stabilised waste, which can be seen in Figure 11, after the permit to proceed was received from the Ugandan environmental authorities.
